Title: Dock unit Typical  
Client: Maple Grove owners Assn.  
PO Box 1630  
Port Angeles, WA 98362

12 October, 2016

Subject: Dock Anchor inspection

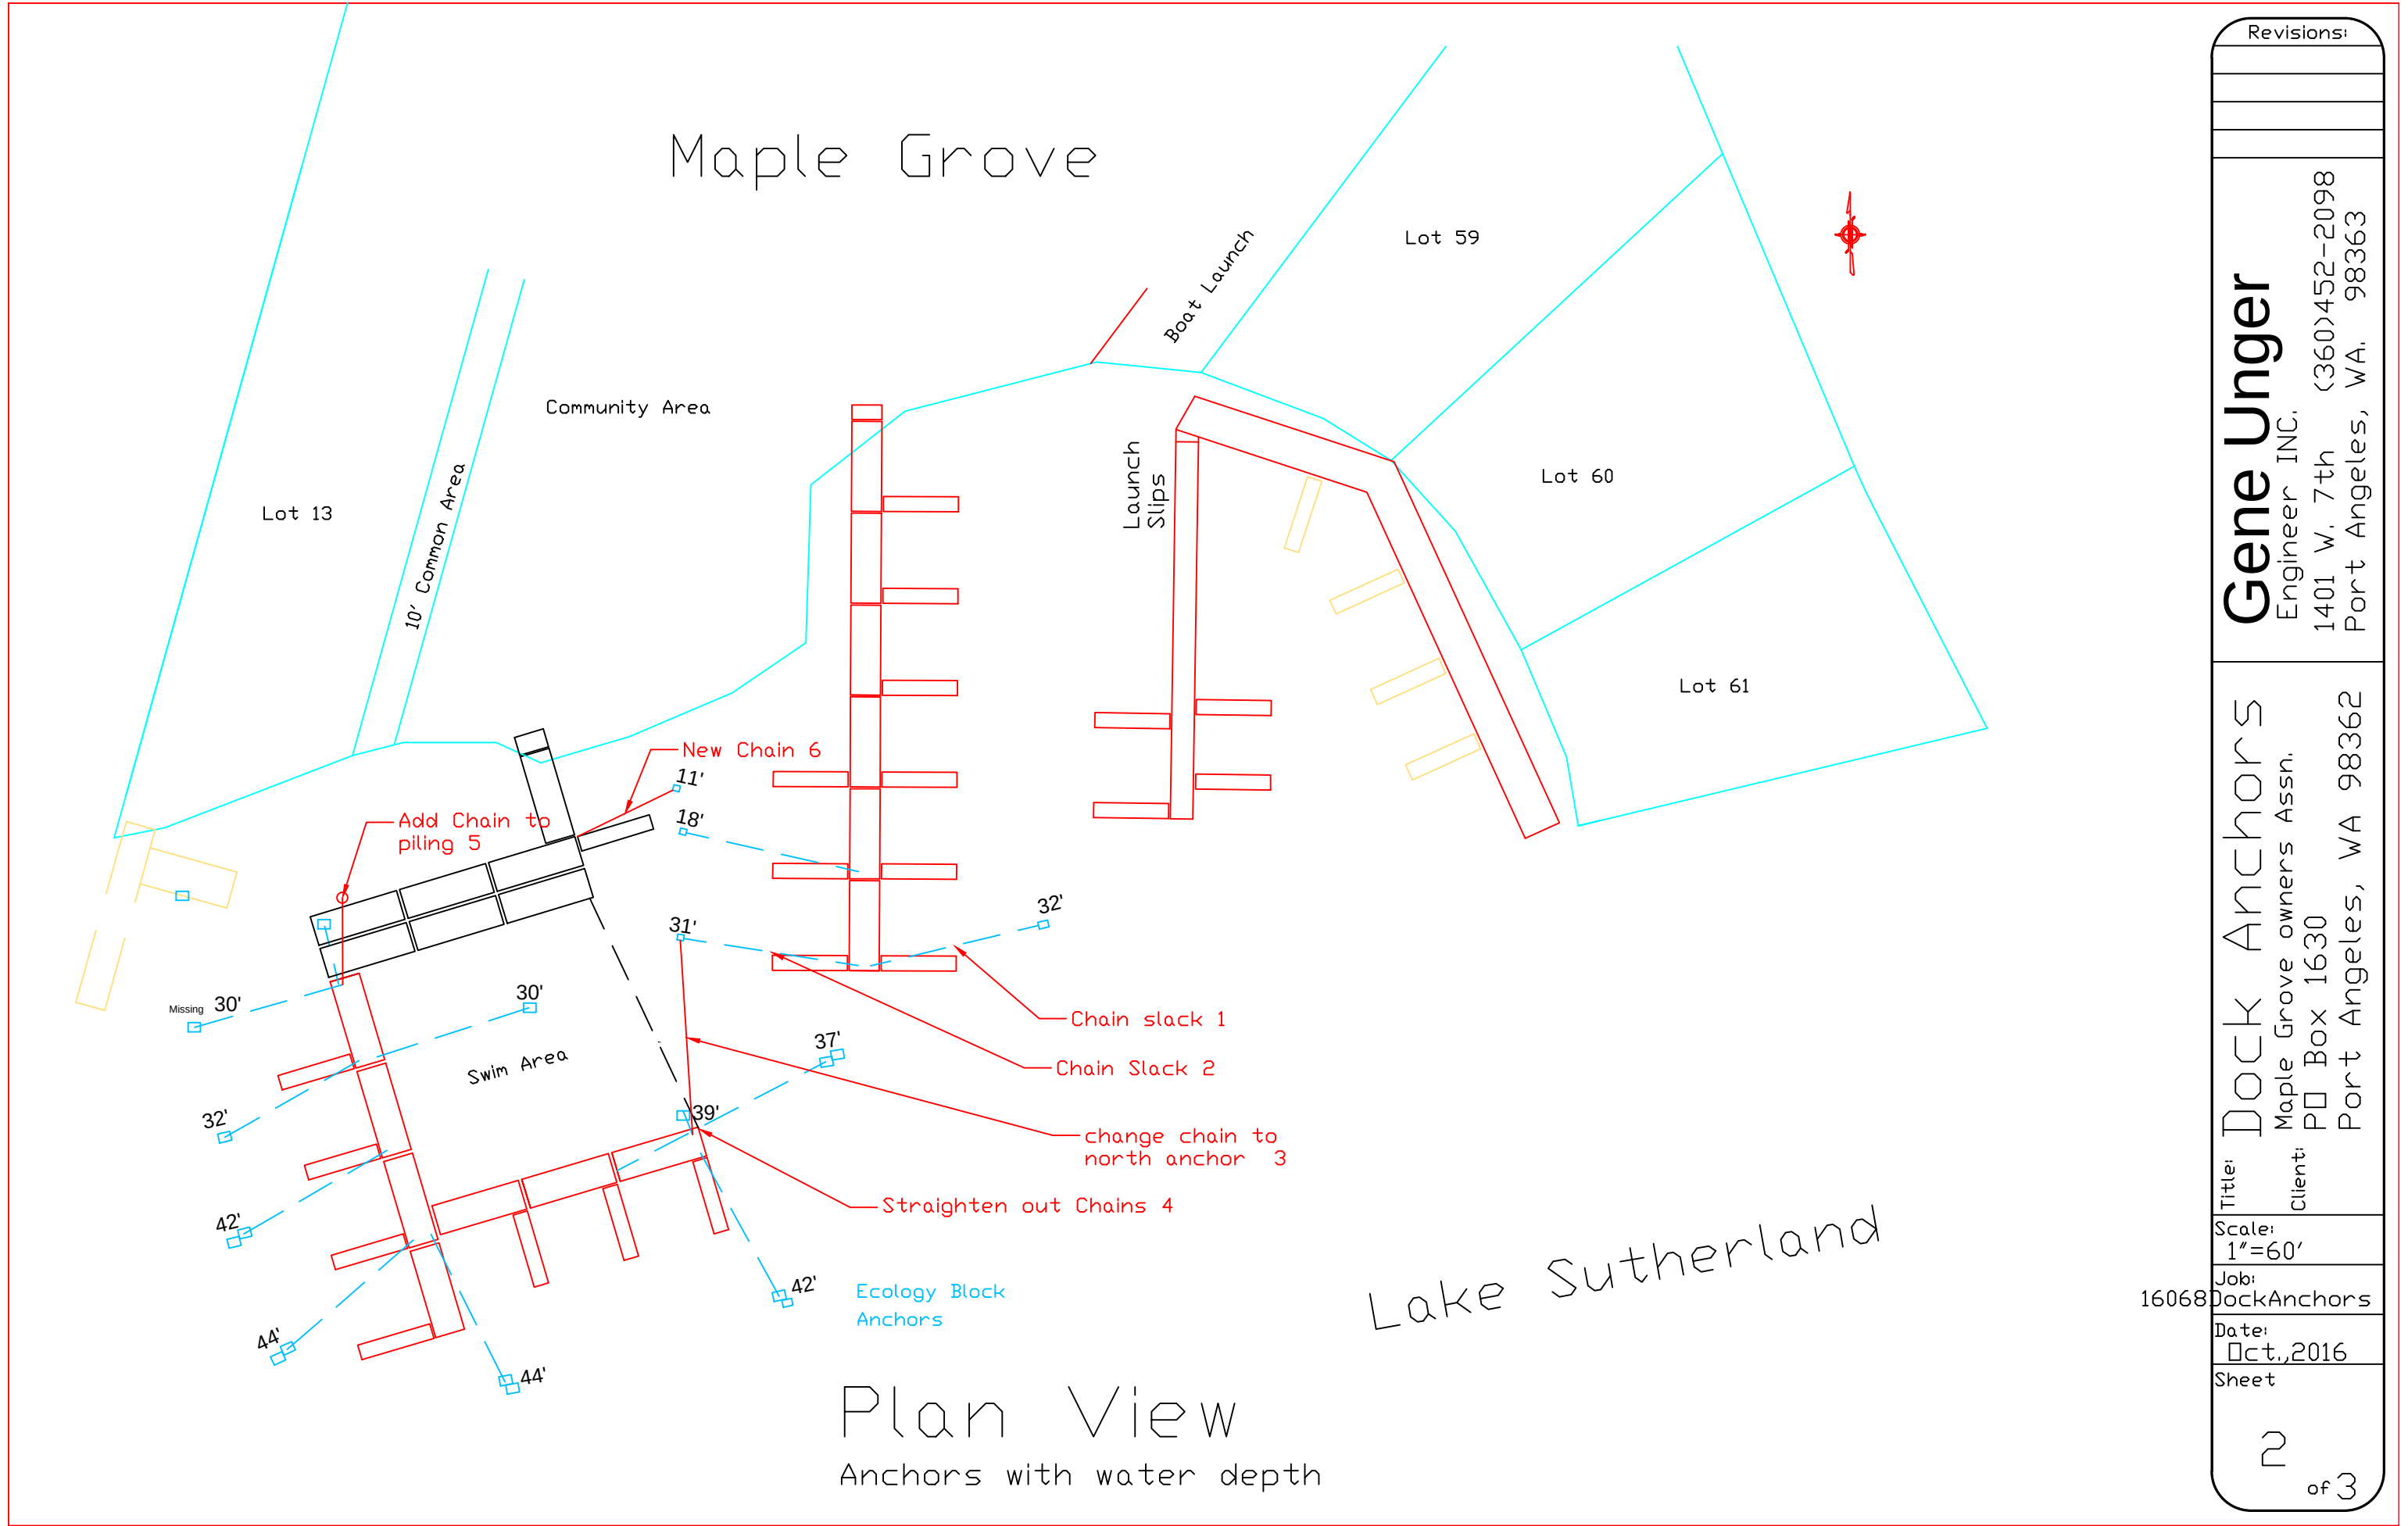
I hired Scuba Supplies with Kathy Lucero to dive the anchors of our dock system to determine their condition. The results are shown on the attached plan. We need to accomplish six (6) adjustments to the anchors to bring them back into position. They are as follows:

1. The chain to the east off the end of finger pier needs to be tightened.
2. The chain to the west off the end of finger pier needs to be tightened.
3. The chain at the end of the "C" pier needs to be moved to the anchor north of that position.
4. The chains under the end of the "C" pier need to be straightened out. This will happen with action "3".
5. An anchor chain needs to be added from the dock to one of the cut off piling.
6. An anchor chain needs to be added from the "C" pier launch span to anchor to the east.

With these corrections in anchorage the dock will have significantly less energy trying to bend the docks. This will significantly reduce the tension trying to tare the launch span to the "C" pier from its first dock.

When this is done it will be time to work on the six north docks of the "C" pier. They need to have the decking removed and have additional 2x4 hold downs for the floats installed. This is most essential to the northeast dock and the southwest dock of the six north docks. Presently the floats are receiving enough wave action that they have worked the present five 2x4's, holding them down, loose so that they are lifting the decking off the dock. The added hold downs shall be installed using 4"x#8 Stainless screws through the stringers. An angled screw holding the 2x4 down should also be installed at each end of the 2x4's into the stringers. The decking can then be installed as it was originally.
